## **Chelan**

Located at Mile Post 8.22 on State Route 971, above Lake Chelan, this 630 foot long by 70 feet high, north-facing slope has been a chronic source of surface erosion and ditch maintenance needs.

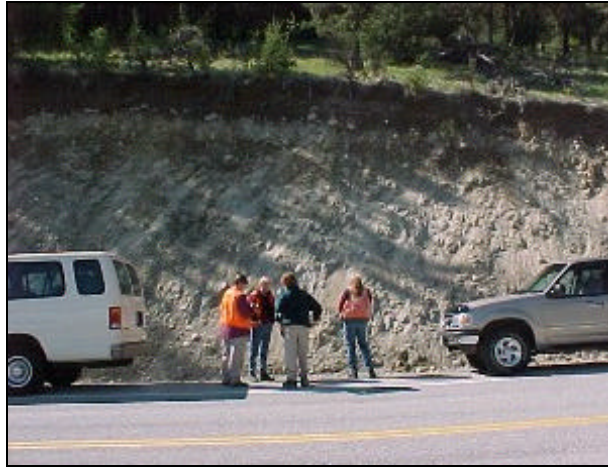
**Figure 1. SR 971, Mile Post 8.22 vicinity, June 1999**

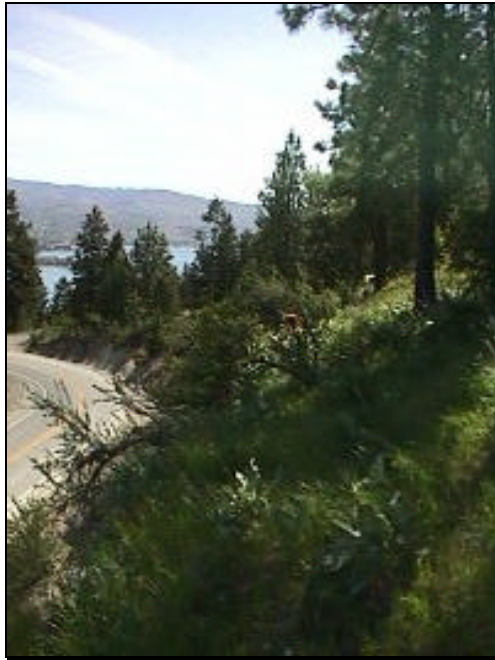
There was sparse existing vegetation on the slope face consisting of a bitterbrush (*Purshia tridentata*) and ponderosa pine (*Pinus ponderosa*) community and one willow (*salix exigua*). See Appendix G. This vegetation was located on portions of the slope that were at an angle of repose of 1.5(V):1(H). Where the slope was steeper, there was no vegetation growing.

The slope above the vertical lip has a ponderosa pine community established. The vegetation, especially the mature trees, growing on the edge are at risk because of continual erosion.

**Figure 2. Vegetation community on stable soils**

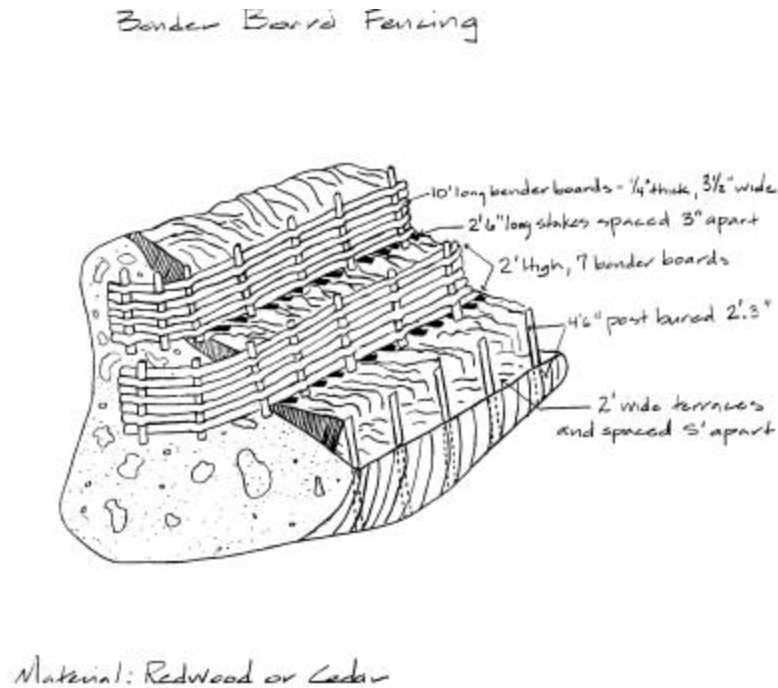
**Figure 3. Bender board fencing**

After consultations with fellow scientists and lumber experts, the PI's solution was to use cedar bender board fencing. The consensus was that the slope would benefit from terracing, but traditional soil bioengineering plant species, such as willow, would not be appropriate for these site conditions. As a result, cedar bender board fencing was used as an alternative to willow walls to reduce the length and steepness of the slope and to create stable planting platforms for easier establishment of native (dry climate) vegetation.

Redwood or cedar bender board fencing is essentially a fence supported on a short layer of shrub or tree stems. Specifically, it is a short retaining wall built of redwood or cedar bender fencing with a stem layered base.

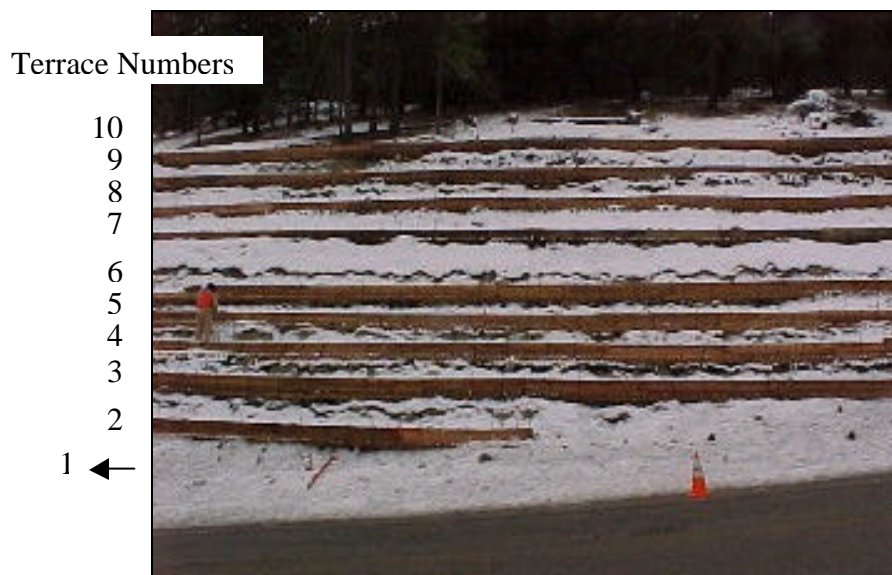
The Crew continued to construct the terraces and bender board fencing until the ground froze too deeply to work. They quit for the season on January 13, 1999. The photo below shows the site at that time.

**Figure 4. End of season - January 13, 2000**

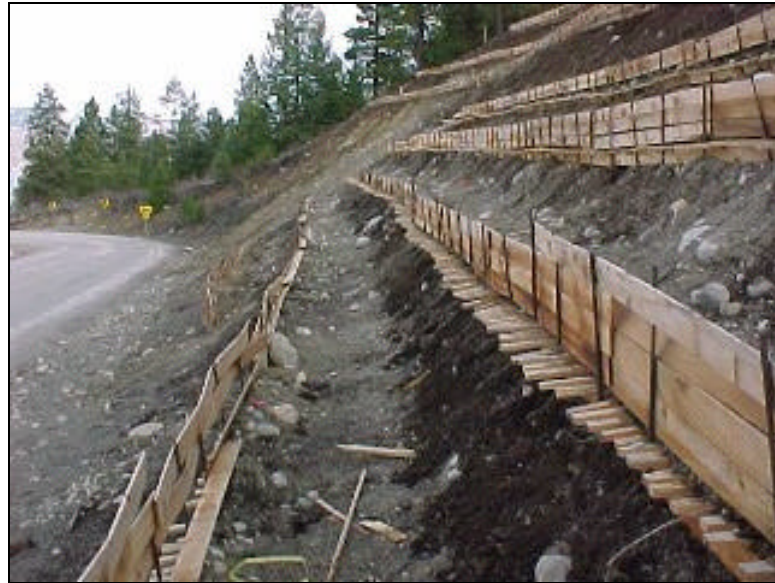
The Landscape Designer checked the site on March 15, 2000 to determine if the soil had thawed and to check for disturbance to the site during winter. Without snow mixed into the soil, the soil had settled, allowing some of the boards to fall back onto the terrace. This can be seen in Figure 6. With the addition of water, areas on the control section had liquefied and moved down slope. However, where compost had been applied, there was no visible movement of soil.

**Figure 5. Status before Spring construction - March 15, 2000**

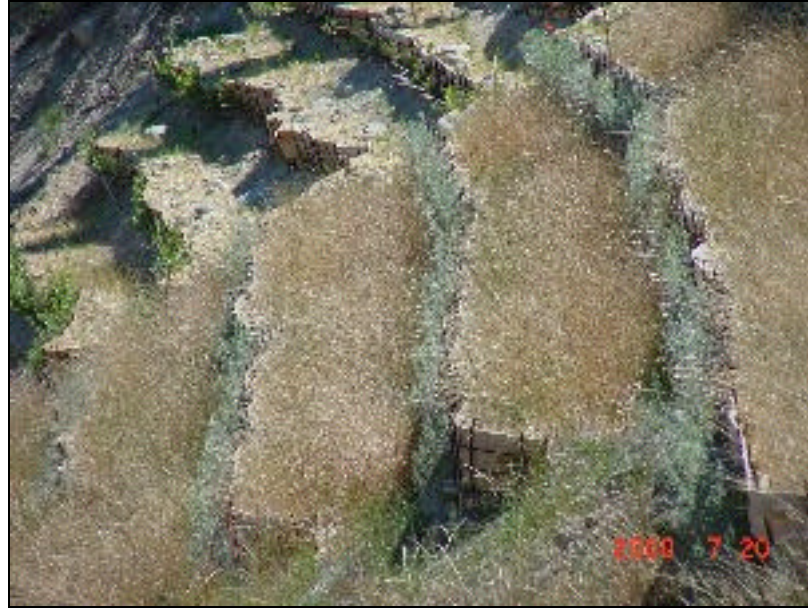
By the end of June the bender board appeared to have stabilized the surface erosion and grass was growing on all terraces, however, where the composted biosolids were applied, The annual rye was thicker, greener and withstanding drought conditions better than the control section without compost as seen in the photo below. The predominant vegetation on the control section was Idaho fescue.

**Figure 6. Grass communities differ with biosolids**

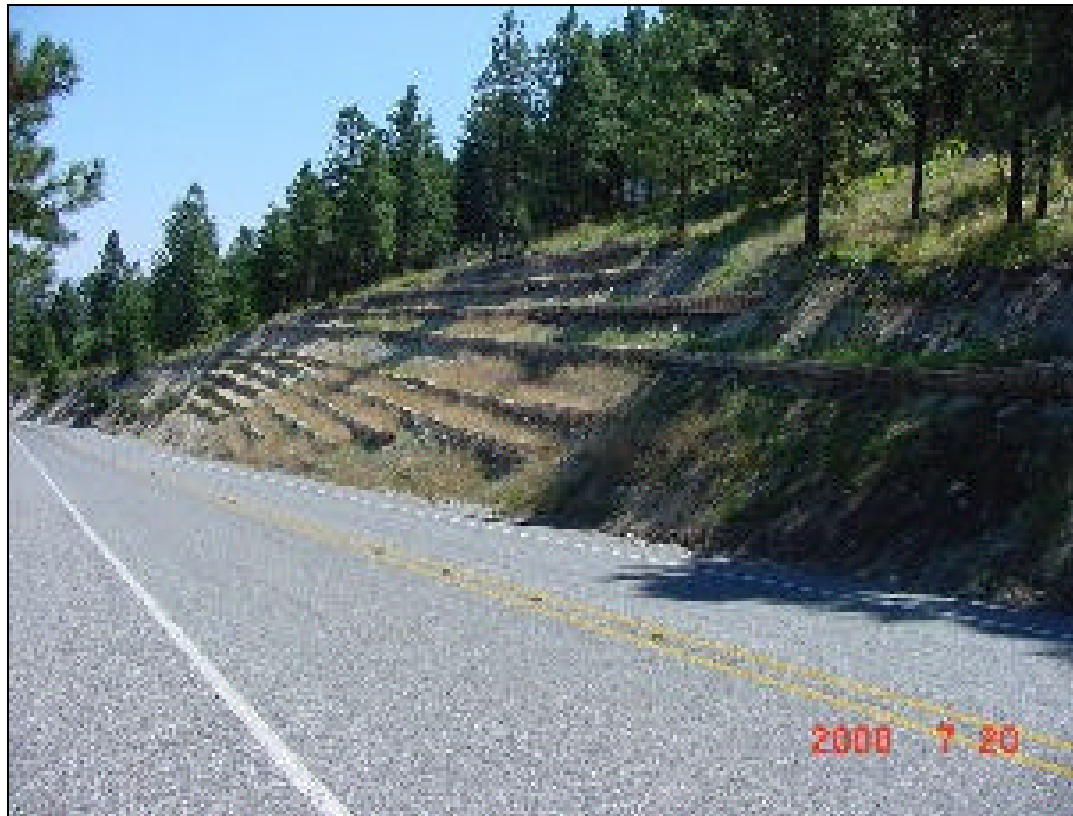
Long-term monitoring will allow WSDOT to determine long term slope stability and to further understand the relationship between native plants, native soil, and biosolids. The status of this site in July 2000 is shown in Figure 8.

**Figure 8. Chelan, July 20, 2000**
